Manhole Inspection Summary

Manhole # S150__031MH

Insp Date: **3/27/08 9:01 AM**

Location Address: **2686 wilkens-st benidict**

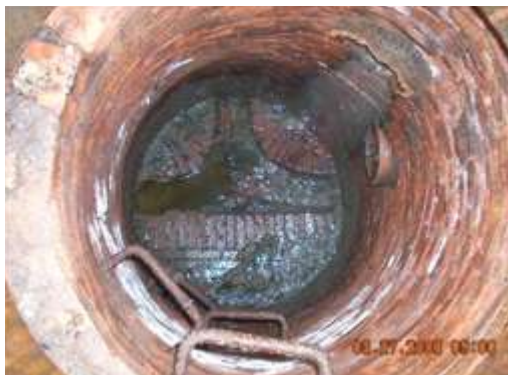
misc

bench debris

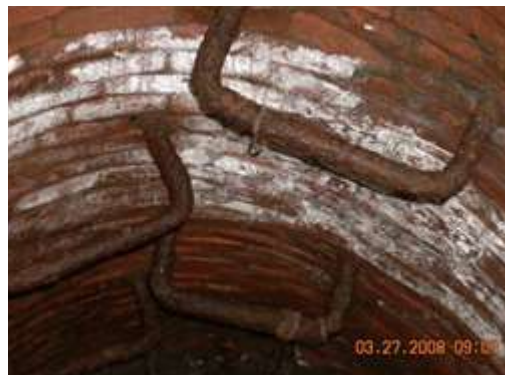
Defect 2

Steps Count: **5** Missing: **0** ☒ Corroded

Surcharge ☒ Evidence Of Surcharge Depth: **4** (ft.) ☐ Active Surcharge Present

SUR. EVIDENCE WALL & steps corroded

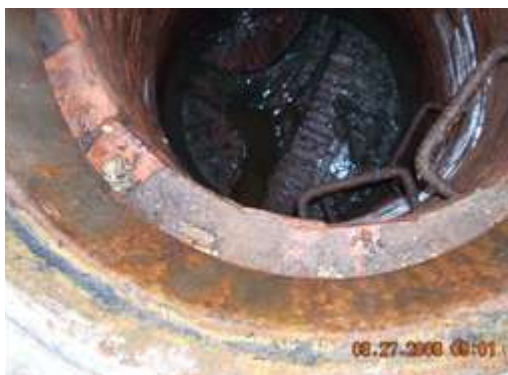
Defect 1

Frame Offset: **3** (in.) Condition: ☒ Sound ☐ Cracked ☐ Leaks

FRAME OFFSET

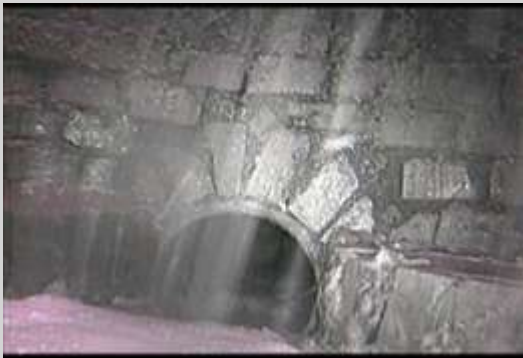
12 O'Clock Outflow

Pipe Height: **8.4** (in.) Rod and Bar (Angled)
Pipe Material: **Clay** ☐ Pipe Lined
Invert Depth: **11.00** (ft.) Flow Characteristics: **Slow**
Deposits: ☐ None ☐ Mud ☐ Sludge ☒ **Debris** ☐ Grease
Silt Depth: **3** (in.) Deposits Extent: **Medium**
Infiltration: **None** Pipe Seal Cond: **Sound**

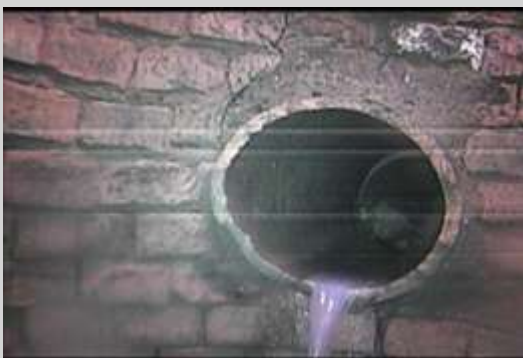
2 O'Clock Inflow

Pipe Height: **8.4** (in.) Rod and Bar (Angled)
Pipe Material: **Clay** ☐ Pipe Lined
Invert Depth: **4.04** (ft.) Flow Characteristics: **Slow**
Deposits: ☒ **None** ☐ Mud ☐ Sludge ☐ Debris ☐ Grease
Silt Depth: **0** (in.) Deposits Extent:
Infiltration: **None** Pipe Seal Cond: **Sound**

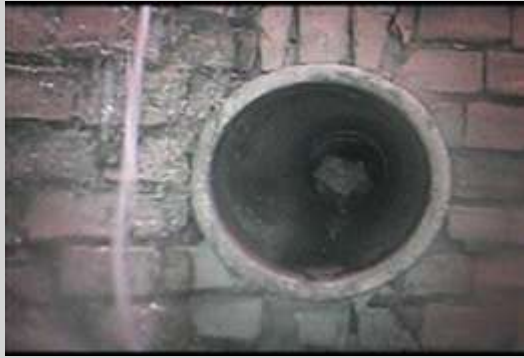
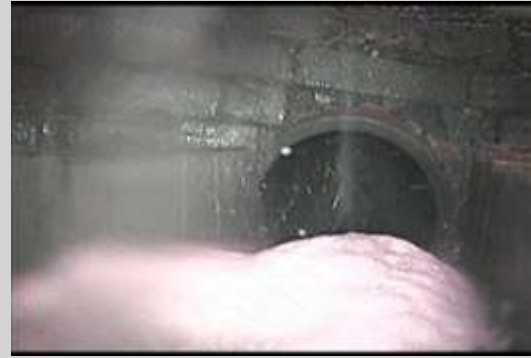
3 O'Clock Inflow

Drop: **Outside** Rod and Bar
Angled: **Yes** Reading: **9.96** (ft.)
Inv Depth: **10.96** (ft.)
Drop Condition: **Open**

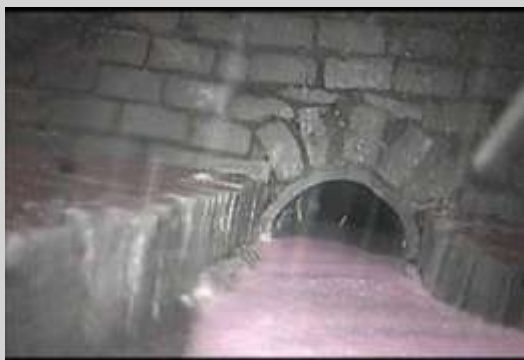
9 O'Clock Inflow

Infiltration: **None** Pipe Seal Cond: **Broken**
